6 National Dam Inspection Program. Number
Musser Forests Dam (NDIVPA-287,
DER IDV 32-65), Ohio River Basin, McKee
Run, Indiana County, Pennsylvania.

PHASE I ~~REPORT~~ Inspection Report,
NATIONAL DAM INSPECTION PROGRAM

NAME OF DAM: Musser Forests Dam
STATE LOCATED: Pennsylvania
COUNTY LOCATED: Indiana
STREAM: McKee Run
SIZE CLASSIFICATION: Small
HAZARD CLASSIFICATION: High
DATE OF INSPECTION: May 23 and 25, 1979

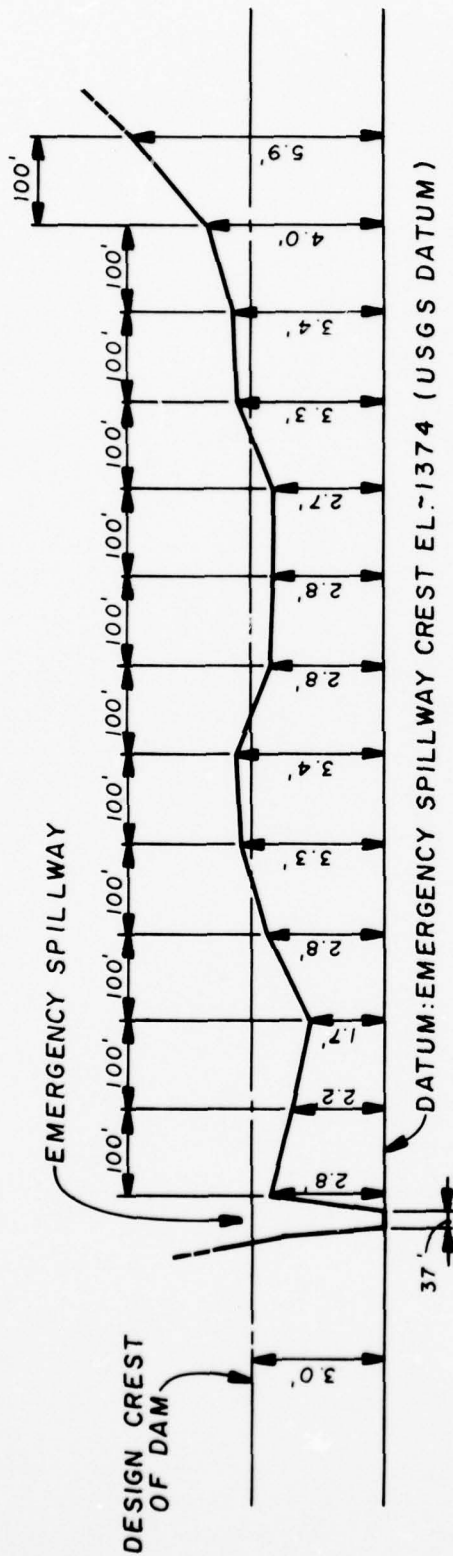
DAM CREST PROFILE
(LOOKING DOWNSTREAM)

Field observations indicate that the crest of the dam is irregular with elevations ranging from 1.7 to 5.9 feet above the emergency spillway crest level. The irregularities do not appear to be due to recent movements. The upstream slope of the dam has no erosion protection and has been partially eroded by wave action. The emergency spillway approach channel is overgrown with tall grass and cattails which may constitute a partial obstruction to flow through the spillway.

The crest of the dam was surveyed relative to the emergency spillway crest level. The freeboard was found to range from 1.7 feet in the vicinity of the primary spillway to 5.9 feet near the right abutment. The dam crest profile is illustrated on Plate 7.

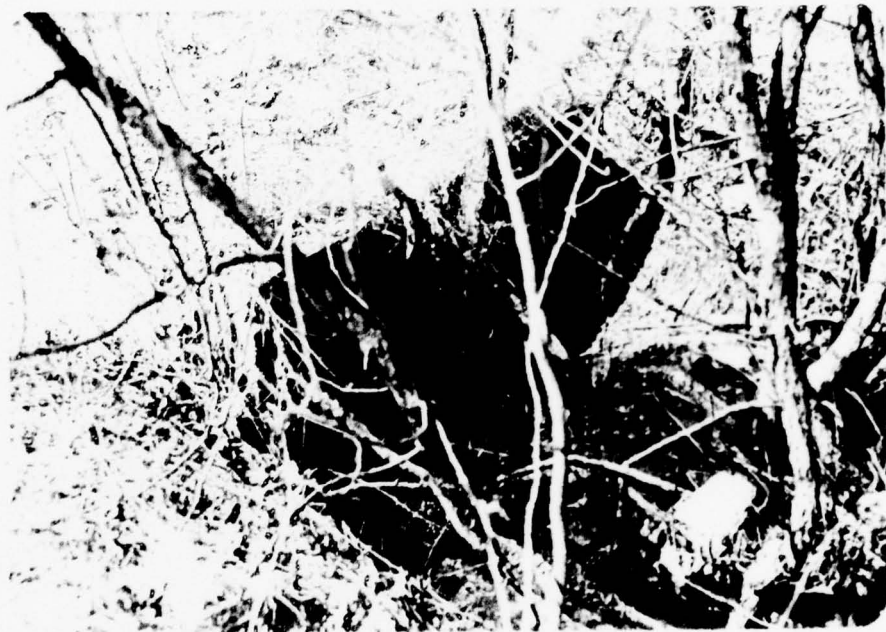
Photograph No. 3
Primary spillway outlet structure.

The emergency spillway approach channel was found to be overgrown with tall grass and cattails which may obstruct flow through the emergency spillway. The spillway discharge channel downstream from the primary spillway was also found to be overgrown with brush and trees which also may constitute obstruction to flow. Although the design drawings show the base width of the emergency spillway to be 50 feet, the field measurements show the base width of the emergency spillway to be approximately 37 feet. The visible portions of the primary spillway structures were inspected and found to be in fair condition.

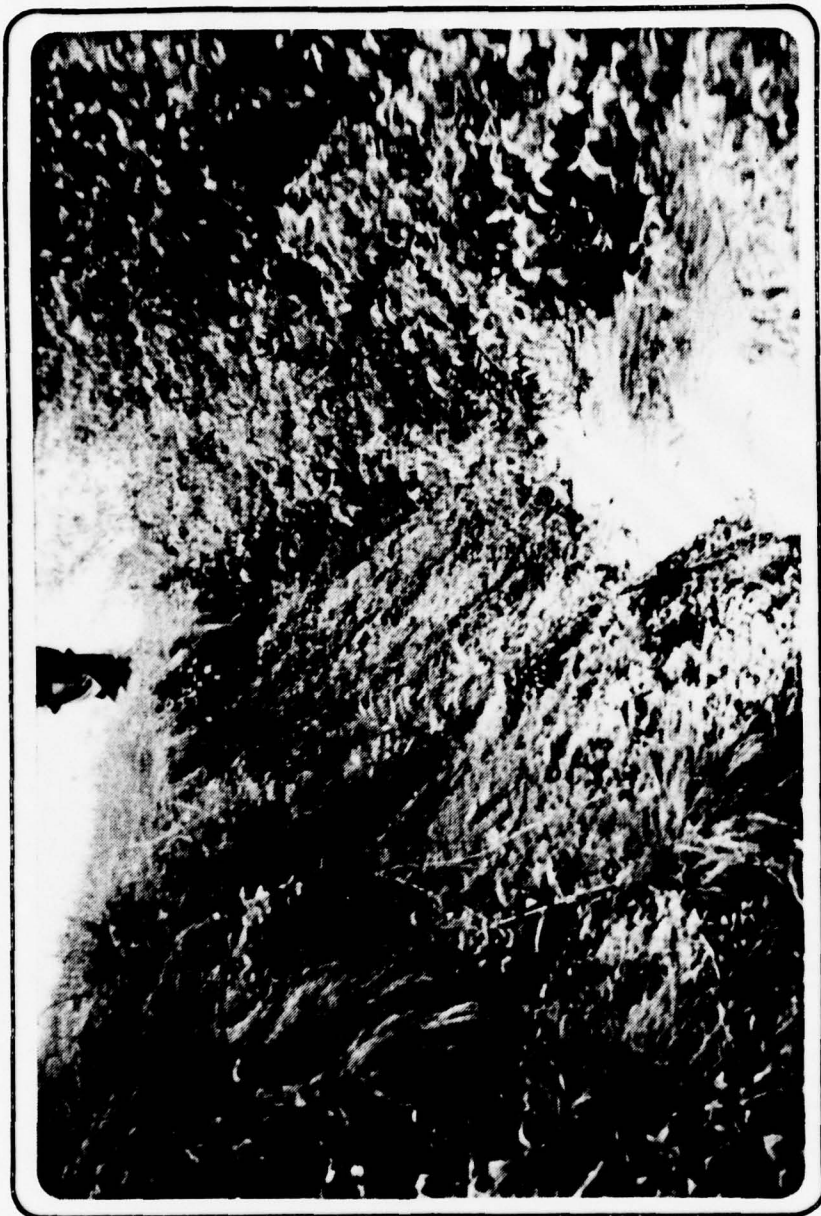
Photograph No. 6

Discharge through the primary spillway discharge channel which follows the toe of the embankment near the left abutment was found to be eroding the embankment toe. At some sections, the toe of the embankment appears to be cut 4 to 5 feet deep by this erosion. This condition is considered to constitute a threat to the integrity of the embankment if allowed to continue. The condition of the remaining portion of the embankment is considered to be fair. The crest of the dam was found to be irregular. However, the irregularities do not appear to be from recent movements. The upstream slope of the dam has no erosion protection and has eroded due to wave action. A wet area was observed at the toe level of the dam at the center of the main embankment. No measurable seepage appears to be associated with this wet area.

(2) Appurtenant Structures. Severe erosion in the spillway discharge channel along the toe of the dam near the left abutment is considered to pose a stability problem to the embankment if this condition is not corrected.

Primary spillway discharge channel. Note erosion along the toe of the dam.

1. The owner should immediately retain a professional engineer to evaluate the erosion in the primary and emergency spillway discharge channel and to prepare and execute plans for providing adequate erosion protection. This study should also consider means of providing emergency drawdown facilities or restoring and improving the existing facilities with upstream closure or control.
